# Manhole Inspection Summary

Manhole # S21K\_\_038MH

Insp Date: **9/26/07 10:32 AM**

**Location** Address: **1910 PRATT ST** Cross Street: **PAYSON-MONROE**

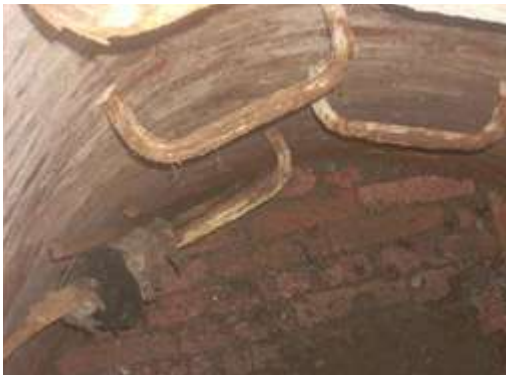
Defect 4

**Steps** Count: **6** Missing: **0** ☒ **Corroded**

**Surcharge** ☒ **Evidence Of Surcharge** Depth: **3** (ft.) ☐ Active Surcharge Present

CORRODED STEPS WITH  
SURCHARGE EVIDENCE

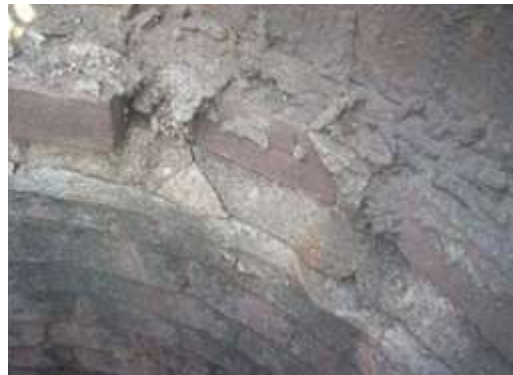
Defect 3

**Chimney / Frame Adjustment** ☒ Exists Material: **Brick and Concrete** ☐ Parged Height: **5** (in.)  
Condition: ☐ Sound ☒ **Cracked** ☐ Root Intrusion ☒ **Loose Brick** ☐ Deteriorated  
Infiltration: ☒ None ☐ Joint ☐ Cracks ☐ Mortar ☐ Roots ☐ Wall

CRACKED CHIMNEY

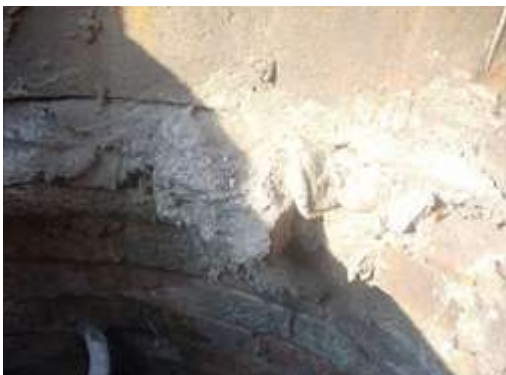
Defect 2

LOOSE BRICKS IN THE CHIMNEY

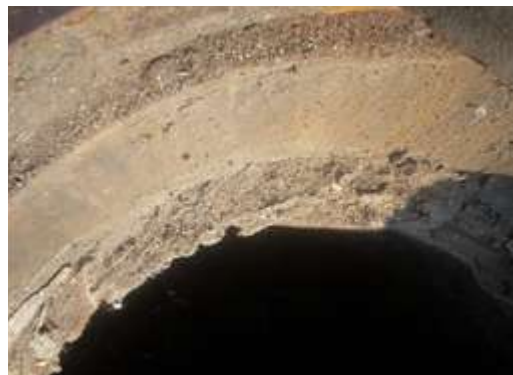
Defect 1

**Frame** Offset: **2** (in.) Condition: ☒ Sound ☐ Cracked ☐ Leaks

FRAME OFFSET

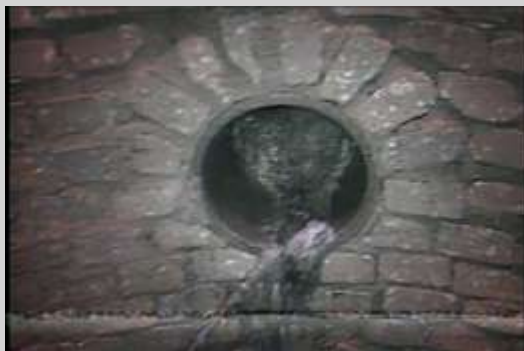
9 O'Clock Inflow

FRAME OFFSET

Pipe Height: **8.4** (in.) Rod and Bar (Angled)  
Pipe Material: **Clay** ☐ Pipe Lined  
Invert Depth: **8.41** (ft.) Flow Characteristics: **Slow**  
Deposits: ☐ None ☐ Mud ☐ Sludge ☒ **Debris** ☐ Grease  
Silt Depth: **6** (in.) Deposits Extent: **Heavy**  
Infiltration: **None** Pipe Seal Cond: **Sound**

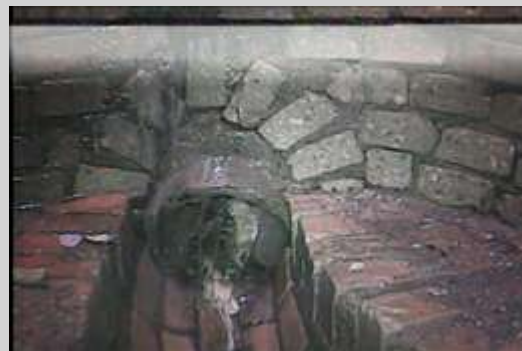
Drop In @ 9 O'Clock

FRAME OFFSET

Drop: **Outside** Rod and Bar  
Angled: **Yes** Reading: **9.14** (ft.)  
Inv Depth: **10.14** (ft.)  
Drop Condition: **Partly Clogged**
